SUMMARY INSPECTION REPORT

PROPERTY: 33 Kingsgarden Road, Toronto, Ontario

INSPECTION REPORT

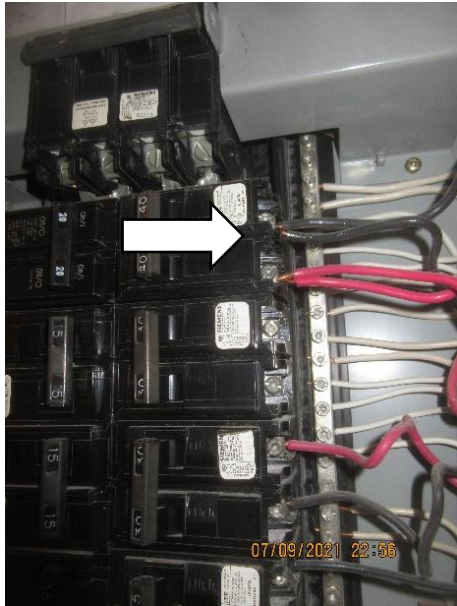
There are numerous 240-volt circuits, and they are protected by circuit breakers. A list of the appliances and the breaker ratings is shown below.

- stove	40-amps
- dryer	30-amps
- air conditioner	20-amps
- garage	40-amps

P: the stove circuit utilizes two separate circuits that share a common 40-amp circuit breaker. An electrician should review the wiring installation for the stove.
