SUMMARY INSPECTION REPORT

PROPERTY: 134 The Kingsway, Toronto, Ontario

INSPECTION REPORT

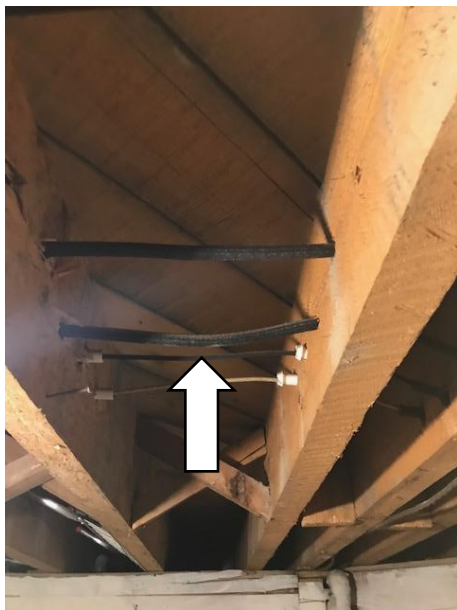
3.02 Distribution wiring: The visible distribution wiring in the house is composed of copper wire. The wiring is largely the original knob-and-tube wire with some modern grounded two conductor cable present-primarily in the kitchen.

P: budget for replacement of all original wire. This would include the installation of additional outlets and possibly additional lighting circuits. The kitchen wiring does not require upgrade. Interconnected smoke/carbon monoxide detectors should be installed on each level as part of the rewiring.

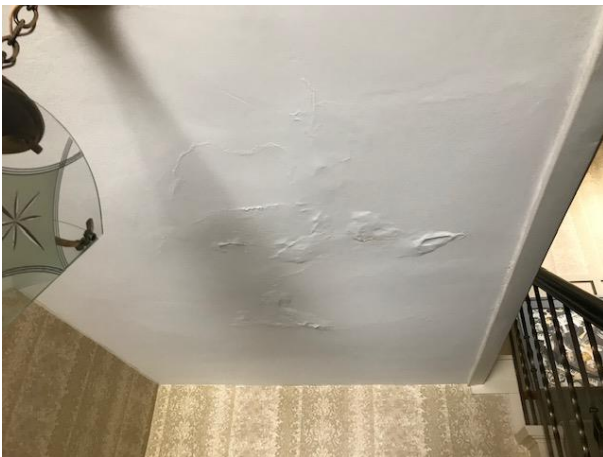
G: the water stains in the front hallway ceiling were checked with a moisture meter and found to be dry during the inspection. The damage was apparently due to an overflow from the bathroom above.
