10 Walford Road, Toronto, Ontario

February 23, 2022

SUMMARY INSPECTION REPORT

INSPECTION REPORT

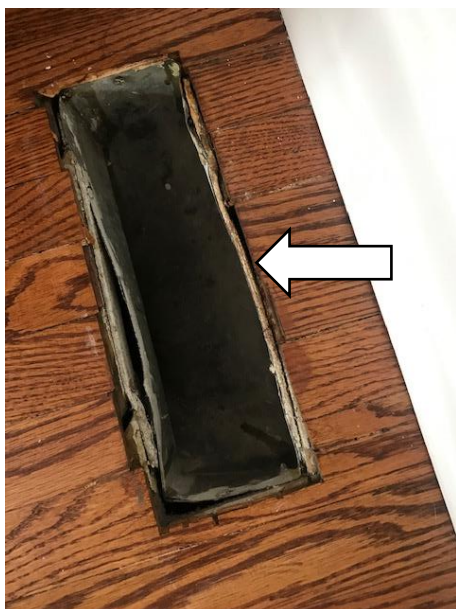
G: asbestos material appears to be present around several of the heat registers where they pass through the flooring. The insulation is located between the floorboards and the metal heat register. It should either be removed or encapsulated to ensure that the fibres do not become airborne.

(Approximate Cost per heat register to remove: \$150 to \$200)

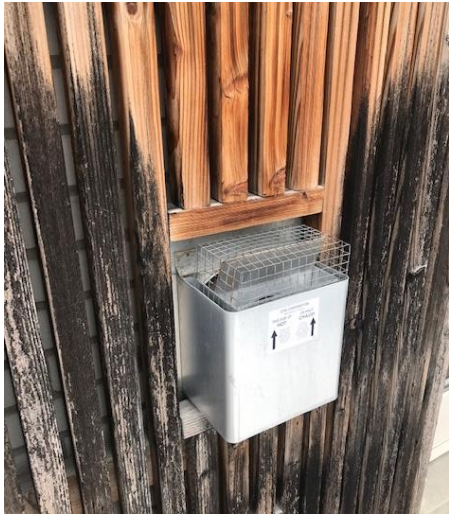
G: the direct-vent fireplace in the rear family room discharges the exhaust gases around wood siding. A metal barrier is required at the top of the exhaust vent.
