169 The Kingsway, Toronto, Ontario

SUMMARY INSPECTION REPORT

PROPERTY: 169 The Kingsway, Toronto, Ontario

INSPECTION REPORT

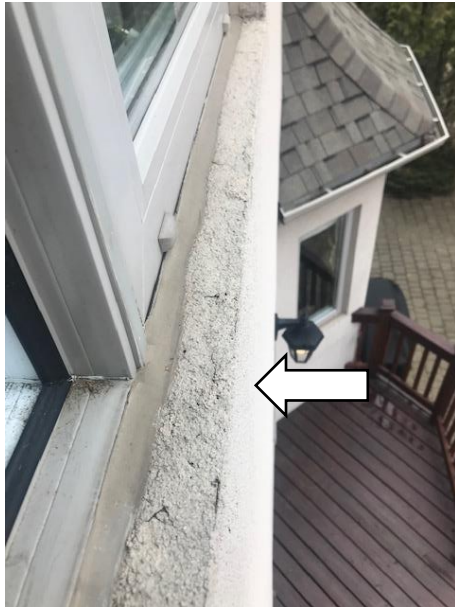
2.09H Synthetic stucco finish: This siding material has been installed over a rigid foam board insulation base and when installed properly can last in excess of thirty years. It is important that all vertical and horizontal joints be kept watertight to prevent water entry into the wall cavities. Synthetic stucco siding is present on the three remaining sides and is in generally good condition.

P: the stucco has deteriorated on both rear bedroom window sills and repairs are required to ensure watertightness.
