## 90 Dunedin Drive, Toronto, Ontario

## SUMMARY INSPECTION REPORT

## **INSPECTION REPORT**

PROPERTY: 90 Dunedin Drive, Toronto, Ontario

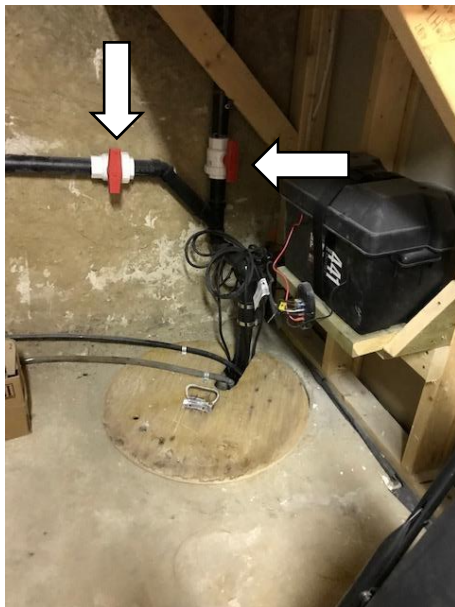
The drain tile that is installed at the base of the foundation wall connects into a sump pump system located in the basement utility room. The sump pump system is equipped with a marine battery backup unit to ensure operation of the pump during power outages. An auxiliary pump appears to be present to ensure continued operation. *Ensure that the sump pump system is in good working order at all times.*

*The sump pump discharges water into the waste plumbing system and also has the ability to discharge water to the exterior at the back corner of the house via a red valve that would need to be manually operated. This option should be used during warm weather conditions.*
