## SUMMARY INSPECTION REPORT

PROPERTY: 195 Humbervale Boulevard, Toronto, Ontario

## INSPECTION REPORT

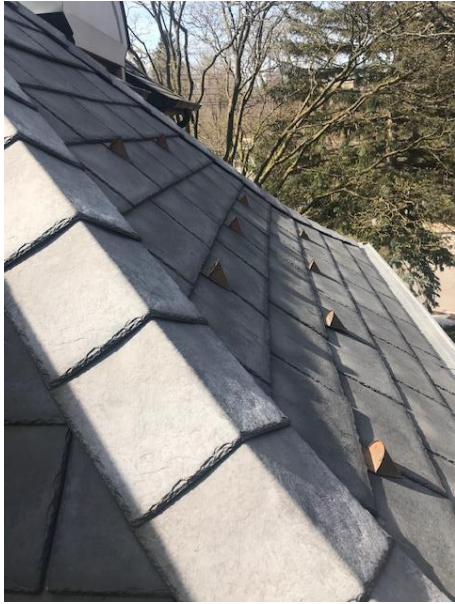
2.03B Synthetic shingled roofs: The roof shingles are a synthetic slate roofing material. No loose shingles were observed. This type of roofing system typically lasts in excess of 40 years.

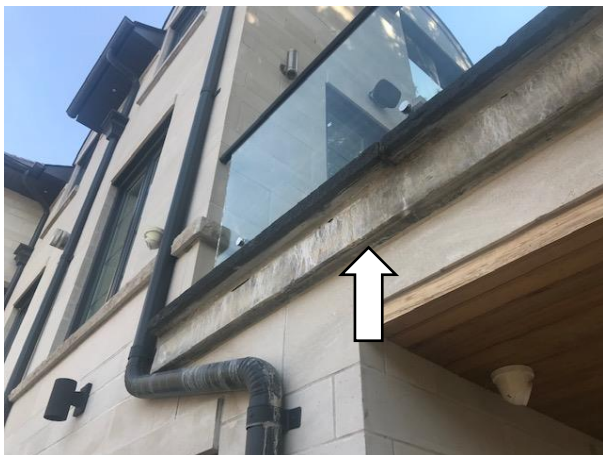
*M: caulking has been applied to the mortar joints between the east deck patio stones that cover the deck surface. This would suggest that there had been moisture penetration through the mortar joints. Monitor.*

*P: there is residue on the perimeter stone finishing below some of the deck surfaces. A drip edge should be provided on the underside of the concrete deck leading edges to shed water away. This may be accomplished with the installation of a bead of caulk or preferably a recessed metal edging.*

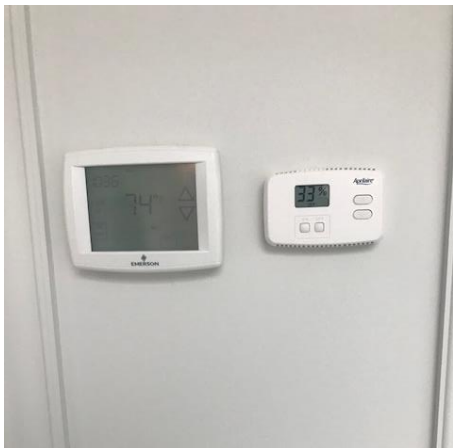
4.01A Type of system: The house is heated by a radiant floor-hot water heating system. The high-efficiency, gas-fired hot water heater provides hot water for both the radiant floor heating system and for domestic hot water use. The hot water heater is located in the basement mechanical room and the exhaust is vented through a plastic pipe on the north side of the house. The hot water heating system is operable. There are numerous thermostats that control heat to various areas of the house.

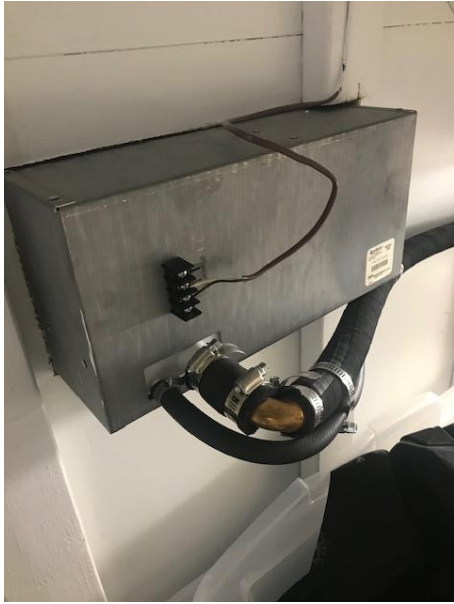
4.03A Steam humidifiers: A steam humidifier is located on the basement level and the humidistat is located on the 2nd floor-west wall.

*G: the equipment is mounted the closet beside the basement staircase and should be isolated to prevent contact with the electrical wiring connections.*

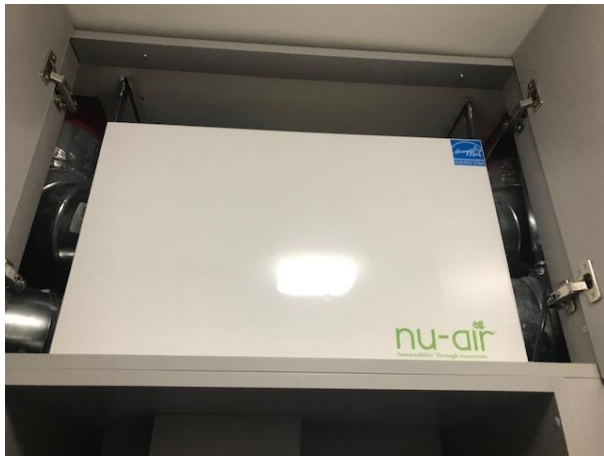
4.03C A HRV (Heat Recovery Ventilating) system is located in a front bedroom upper closet and this system extracts air from the bathroom areas. A humidistat is located in each bathroom.

*P: the system could not be made to operate and ventilation in the bathrooms was not verified.*

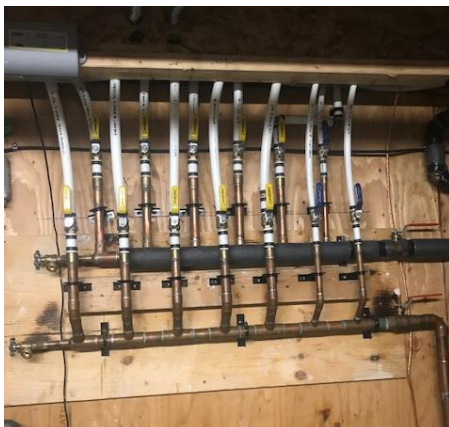
As discussed previously in the heating section, the hot water heater provides not only hot water for the radiant floor heating system, but also for domestic hot water use.
