23 Bridgeview Road, Toronto, Ontario

SUMMARY INSPECTION REPORT

PROPERTY: 23 Bridgeview Road, Toronto, Ontario

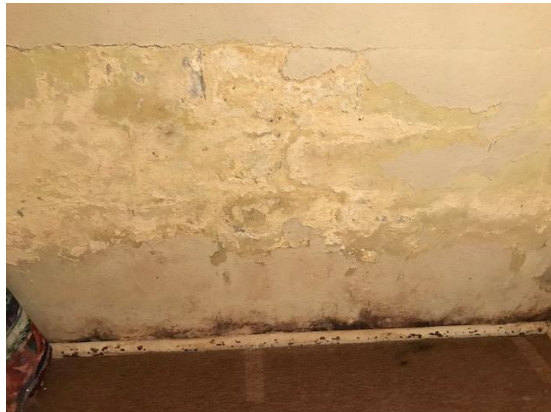
1.02 Water penetration: The basement walls and floors were examined for evidence of water seepage. It is usually not possible to determine the severity and regularity of such problems without monitoring the walls over several months. Most water problems are a result of non functioning eavestroughs, downspouts, or poor surface drainage.

G: as is typical of older homes, foundations often have either no waterproofing or what is there is ineffective. Localized seepage is a possibility due extraordinary rainfall or neglect of eavestroughs or correct surface drainage. There is mildew growth at the base of the southeast rec room wall. This should be scrubbed off. An interior waterproofing membrane and drain tile system (known as 'Delta' membrane), is recommended as part of any significant basement renovations. A dehumidifier should be operated in the basement during the summer months.

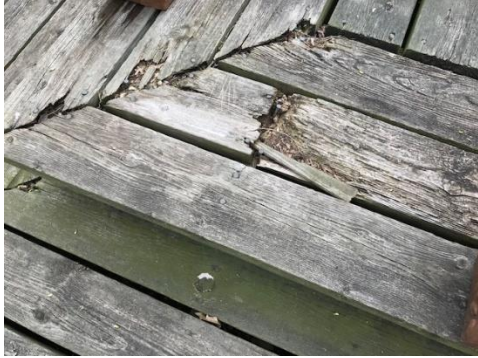
2.11A Wooden deck: The wood deck at the rear appears to be in generally good structural condition. Most deck boards are intact and the steps are functional.

P: the NE step corner of the step structure is rotted and replacement of deteriorated boards is required. Some of the framing below the deck boards in this location may also be rotted.

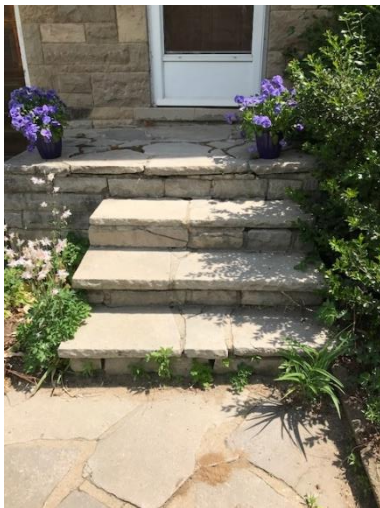
2.11B Concrete stoop:

P: some of the flagstones have loosened or are uneven and should be reset on the front concrete deck structure. The missing mortar between stones should be replaced. There has been some minor movement in the deck slab and steps. Monitor.

P: a set of guardrails and a handrail is recommended to prevent a falling hazard.
